Manhole Inspection Summary

Manhole # S23M1_004MH

Insp Date: **1/21/09 10:08 AM**

Location Address: **3036 Stranden-Mallview**

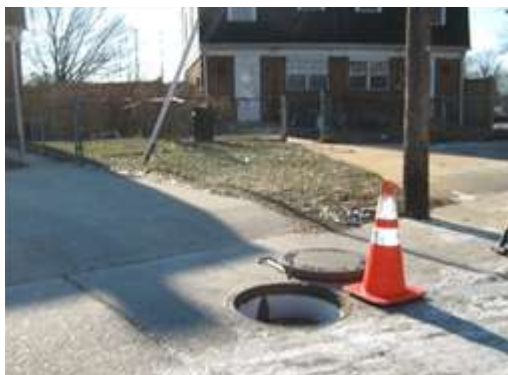
Location View

3036 Stranden-Mallview alley

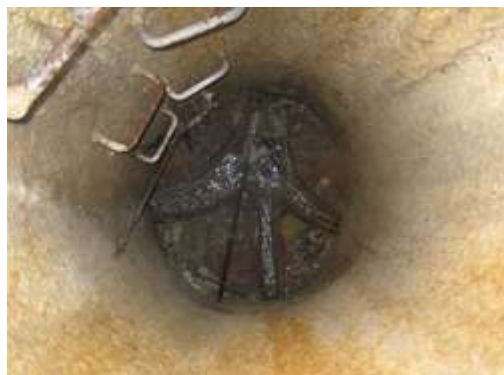
Top View

Comments **Parged from chimney to barrel...unable to determine length of chimney,12 partially clogged**

Parged from chimney to barrel

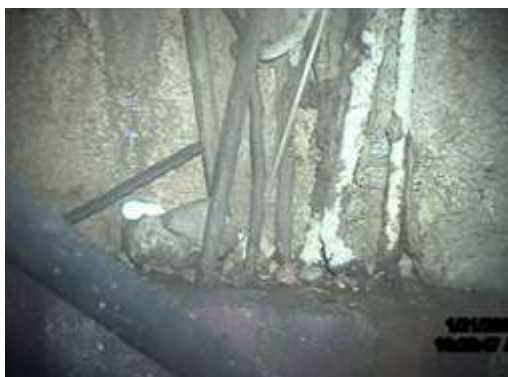
Miscellaneous

debris on bench

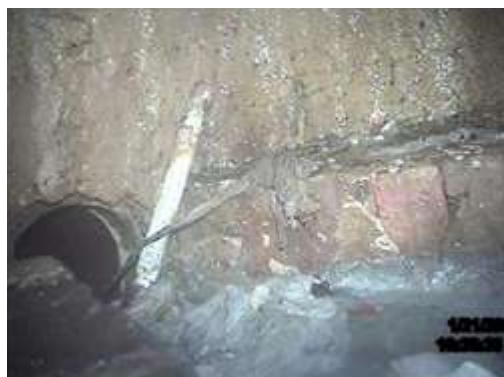
Misc

debris in channel

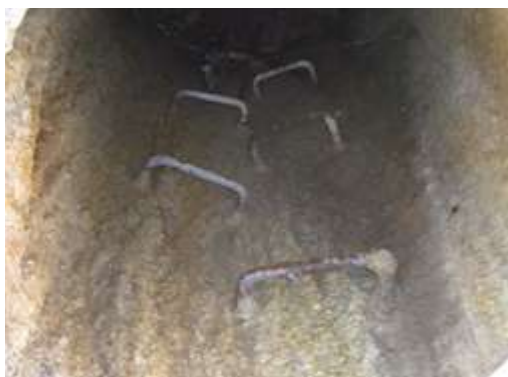
parged (pic2)

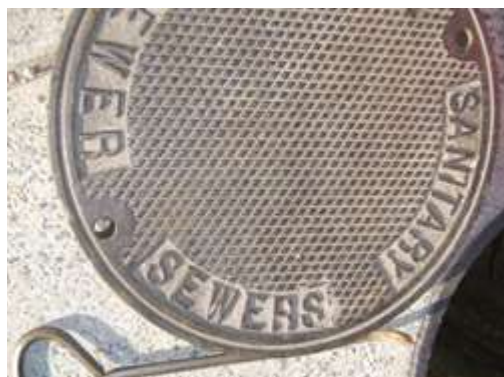
mh cover

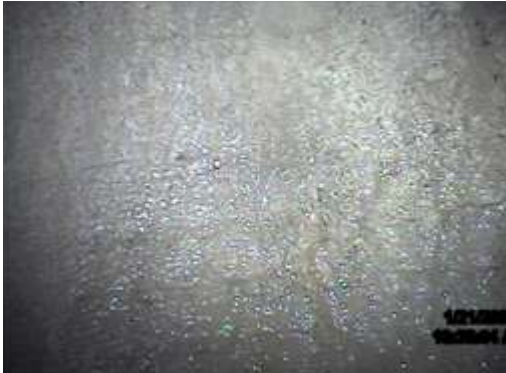
Defect 3

Infiltration: ☐ None ☒ **Joint** ☐ Cracks ☐ Mortar ☐ Roots ☒ **Wall**

infiltration in corbel

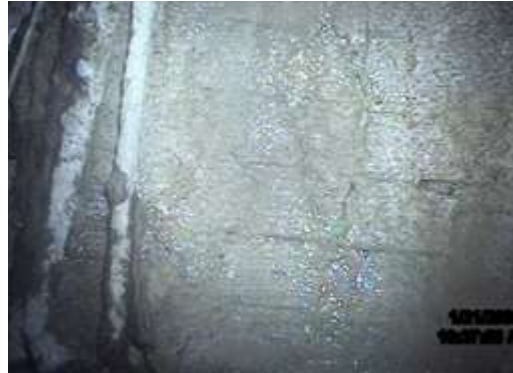
Defect 2

Infiltration: ☐ None ☒ **Joint** ☐ Cracks ☐ Mortar ☐ Roots ☒ **Wall**

infiltration in barrel

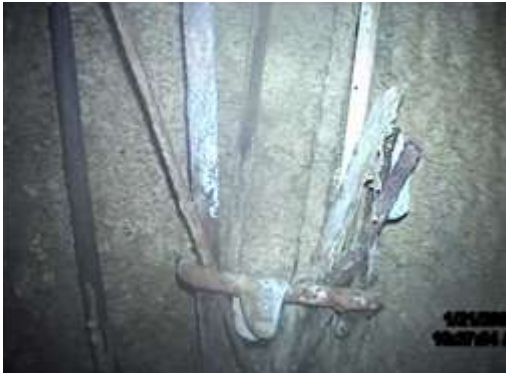
Defect 1

Steps Count: **7** Missing: **0** ☒ **Corroded**

Surcharge ☒ **Evidence Of Surcharge** Depth: **2** (ft.) ☐ Active Surcharge Present

corroded steps, evidence of surcharge @ 2ft

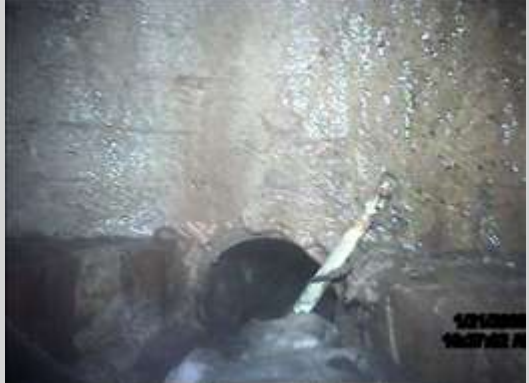
12 O'Clock Outflow

Pipe Height: **8.4** (in.) Rod and Bar (Angled)
Pipe Material: **Clay** ☐ Pipe Lined
Invert Depth: **11.77** (ft.) Flow Characteristics: **Slow**
Deposits: ☐ None ☐ Mud ☐ Sludge ☒ **Debris** ☐ Grease
Silt Depth: **3** (in.) Deposits Extent: **Medium**
Infiltration: **None** Pipe Seal Cond: **Sound**
